[Flashing the Deck, Balcony or Landing](#)

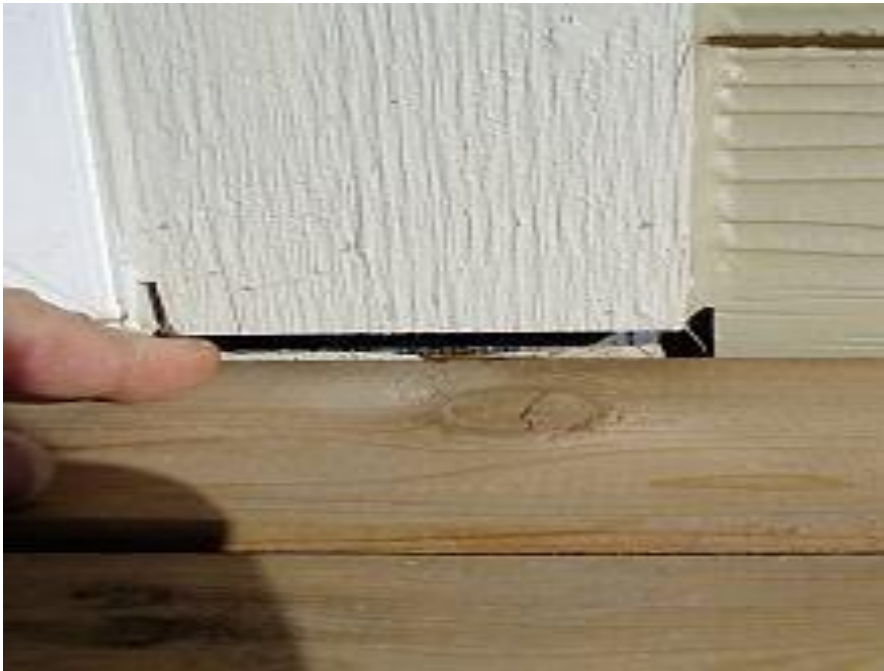
There is no flashing installed at this deck. Consider this: When rain collects on a flat surface (the deck) the water will, inevitably, be routed against the exterior wall. That may lead to seepage of water into the wall and even related structural damage. It is harder, after the fact, to install a flashing at an existing deck or porch. The irony of it all is that it would have been so easy to put in a proper flashing in the first place. Here is an explanatory photo:

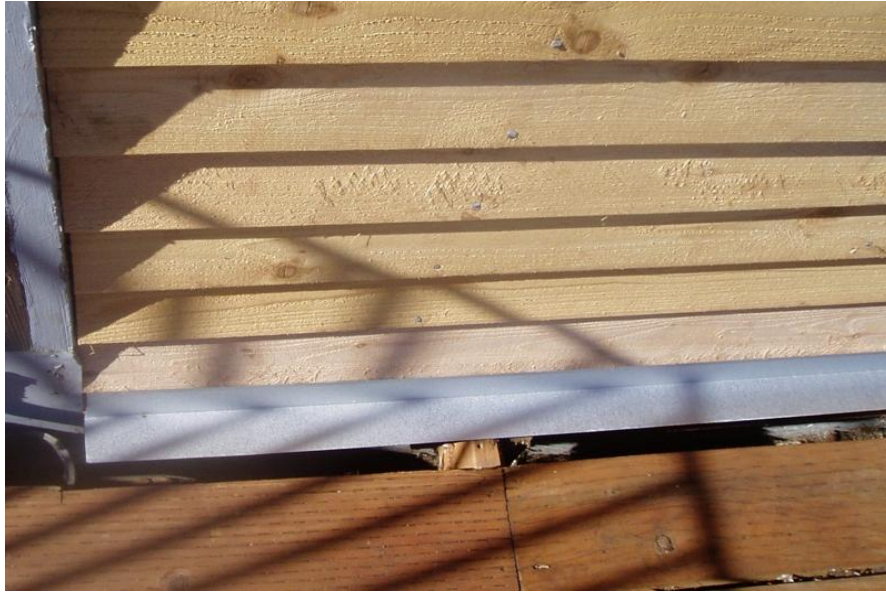
At the most common type of deck, where the ledger board attaches to the side of the house, an L-shaped metal flashing goes up behind the cladding and then it runs out over the top of the ledger board. This flashing looks wide at the bottom because the final decking board has yet to be nailed or screwed into place. It will go down over the flashing but there needs to be a gap left at the top so the siding does not directly touch the decking. If it does, moisture will collect between the two surfaces.

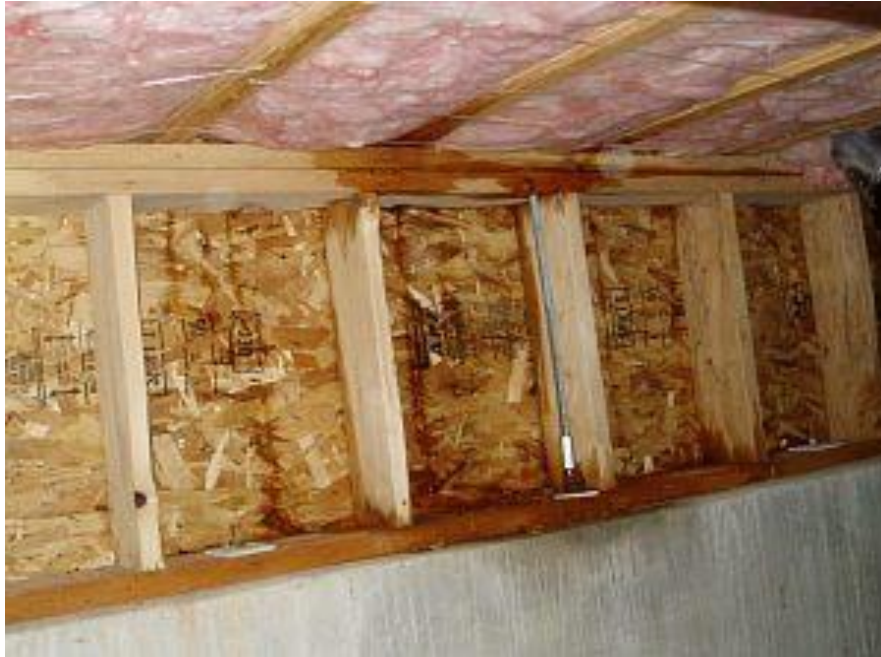
The dark areas are water intrusion at the inside of a crawl space — right behind the missing deck flashing. The siding is cement-based but it isn't bullet proof. The house is only four years old and, had this problem not been caught early on, that water issue would have led to wood destroying organisms and fungal issues. If this deck had been in an area that was not exposed to wind and rain, maybe it would have worked-out better. But, surely, it is apparent that a proper flashing is the best insurance against moisture entry. If you want additional information on installing flashings, you are encouraged to perform an Online search or simply purchase a book on building decks.
